NASA WG3 MMOD Protection Summary

33rd Interagency Space Debris Coordination Committee (IADC)
March-April 2015

Summary of MMOD Protection Activities

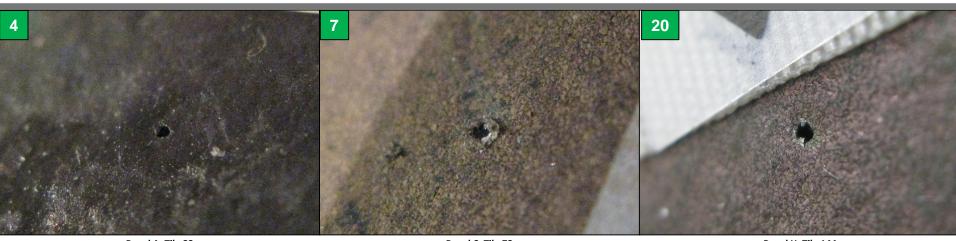
Panel A, Tile 33
Feature Size = 0.51 x 0.50 mm
Depth= 0.50 mm

Panel C, Tile 73
Feature Size = 1.29 x 1.10 mm
Depth= 0.05 mm

Panel H, Tile 144
Feature Size = 0.63 x 0.56 mm
Depth= 0.54 mm

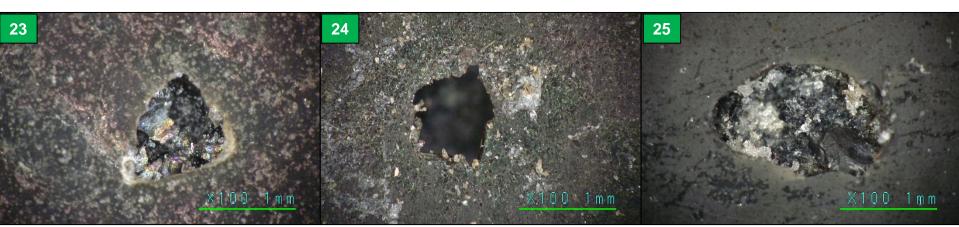
<u>Panel I, Tile 45</u> Feature Size = 1.18 x 1.15 mm Depth= 0.60 mm

Panel F, Tile 45
Feature Size = 1.06 x 1.02 mm
Depth= 1.02 mm

Panel A, Tile 8
Feature Size = 1.88 x 1.27 mm
Depth= 0.70 mm
